CYLINDER HEAD HOLESAWING PROCEDURE

CHRYSLER 426 ST. HEMI

383-440 V-8 B ENGINE

273-360 V-8 A ENGINE

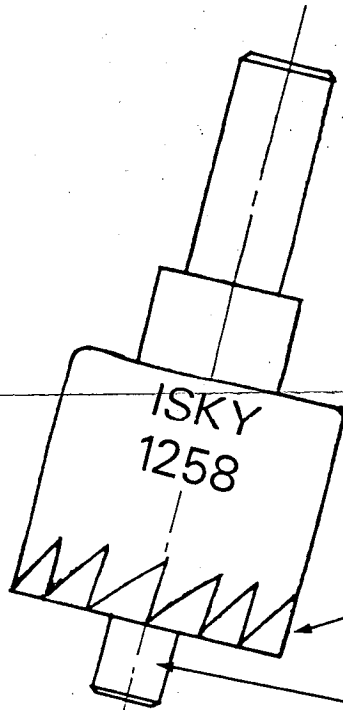
This area must be machined so inner spring can seat flush with outer spring seat.

Drive with 1/2 H.P. electric hand drill 200-400 RPM and machine inner step until cutter barely kisses outer spring seat. Use one drop of oil on pilot stem only.

Specify valve stem pilot size: 426 Hemi — 5/16 dia.
B Engine — 3/8 dia.
A Engine — 11/32 dia. (early 273 engines)
— 3/8 dia. (all '66 & later engines)

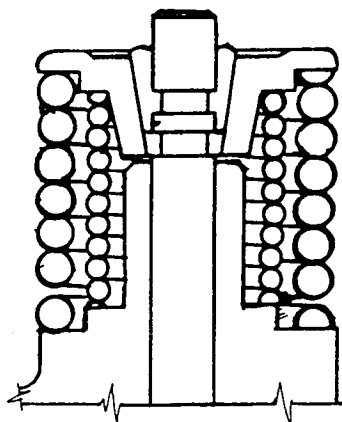
Stock Head Unmachined

WRONG

Note inner spring stacks solid before outer spring, usually undetected by amateur mechanics.

****Dangerous: THIS CAN DESTROY YOUR ENGINE**

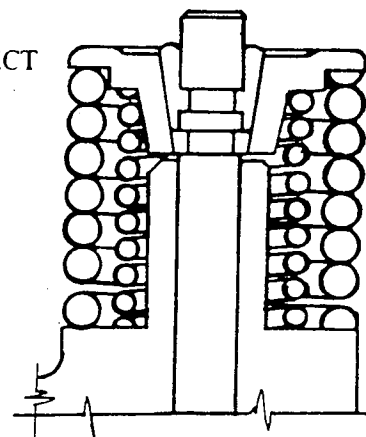
Same Cylinder Head Machined with Holesaw

CORRECT

Note even at full valve lift there is no "STACK SOLID" condition because the 1/8" step has been machined off.

GOOD, SAFE, PROPER PROCEDURE
