67 Satellite passenger seat  
rebuild

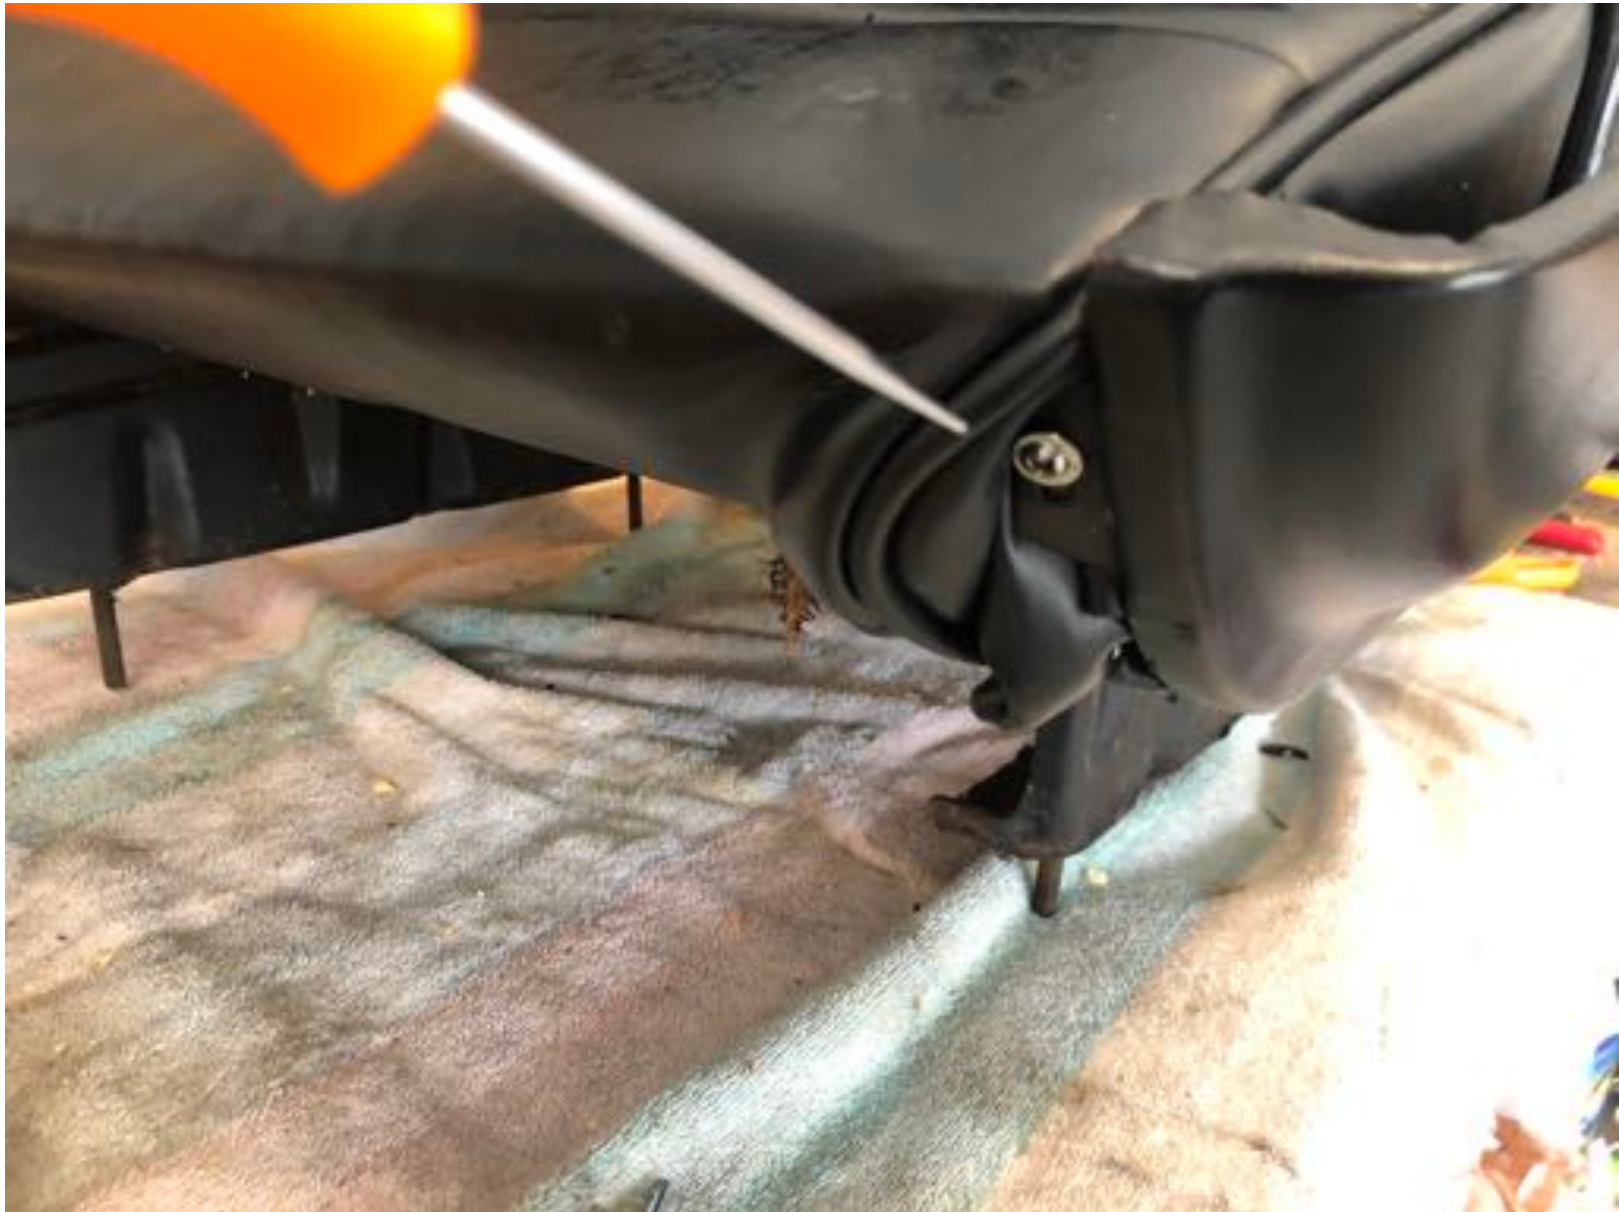
Outside metal panel comes off with two screws, this is the rear

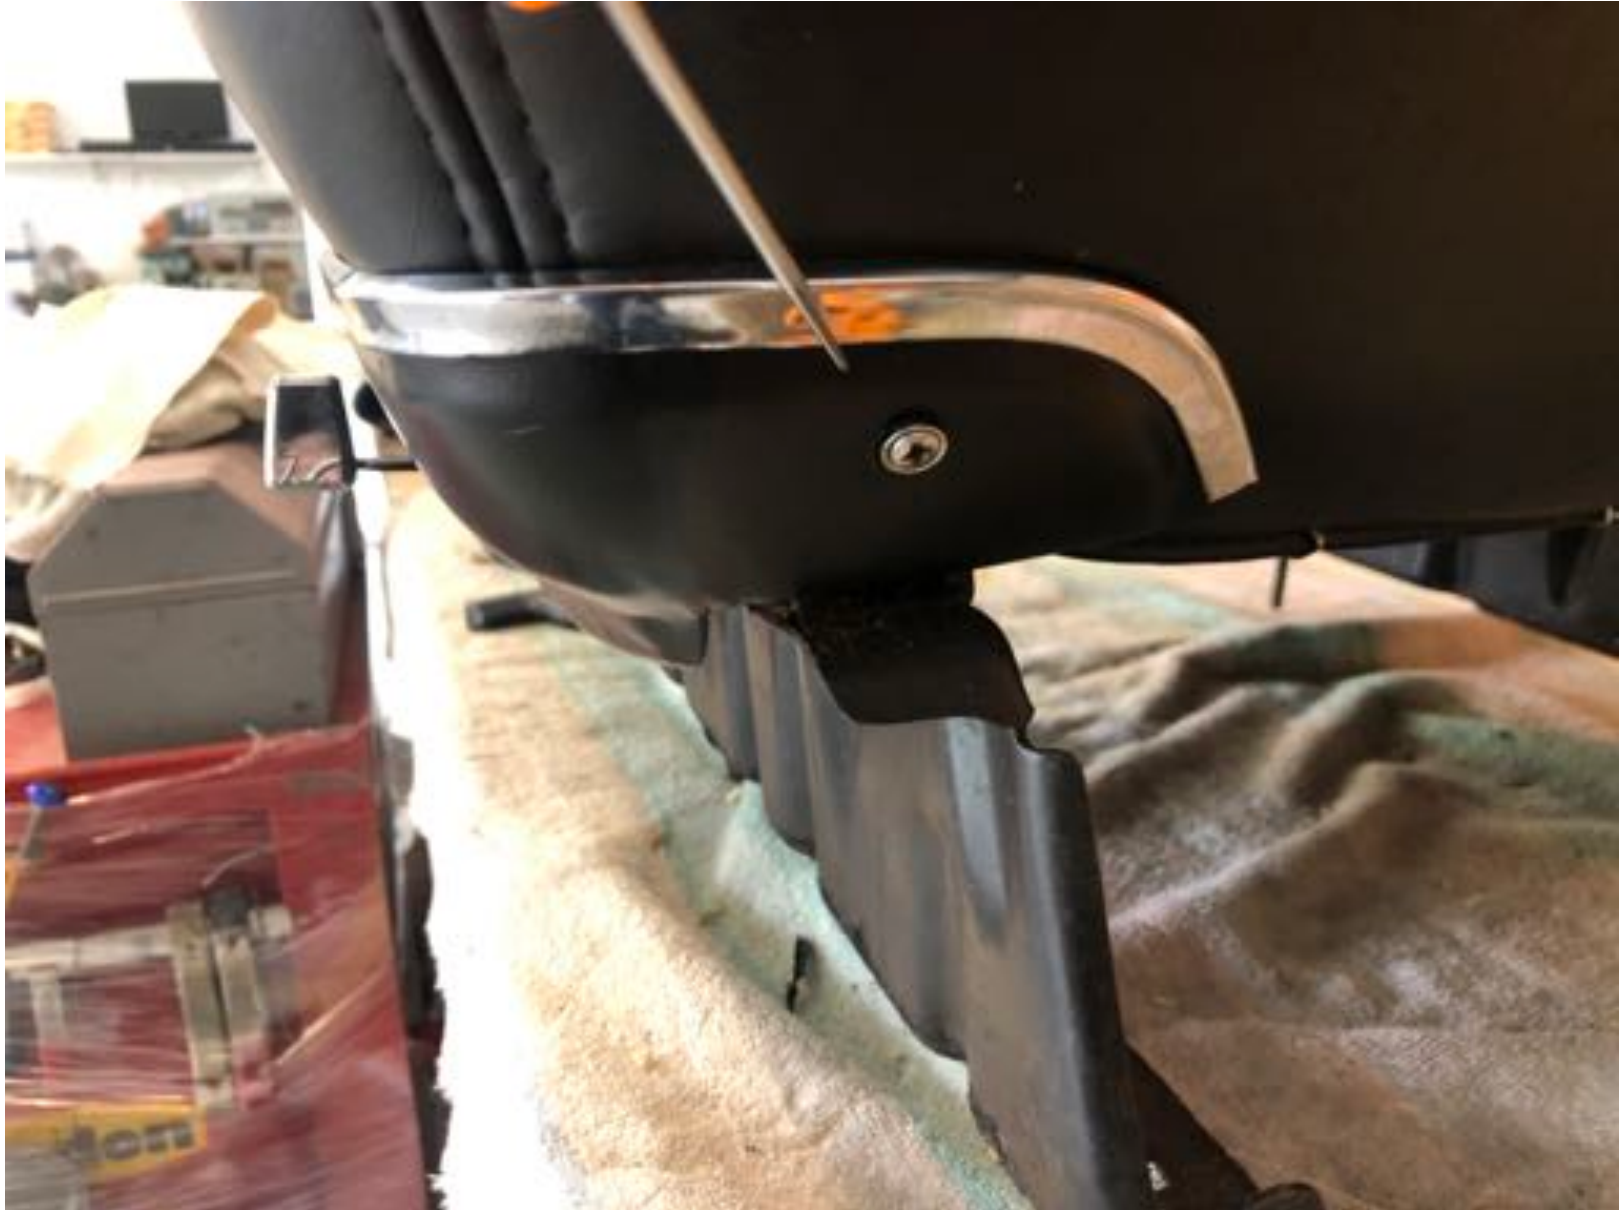
Outside metal panel comes off with two screws, this is the front

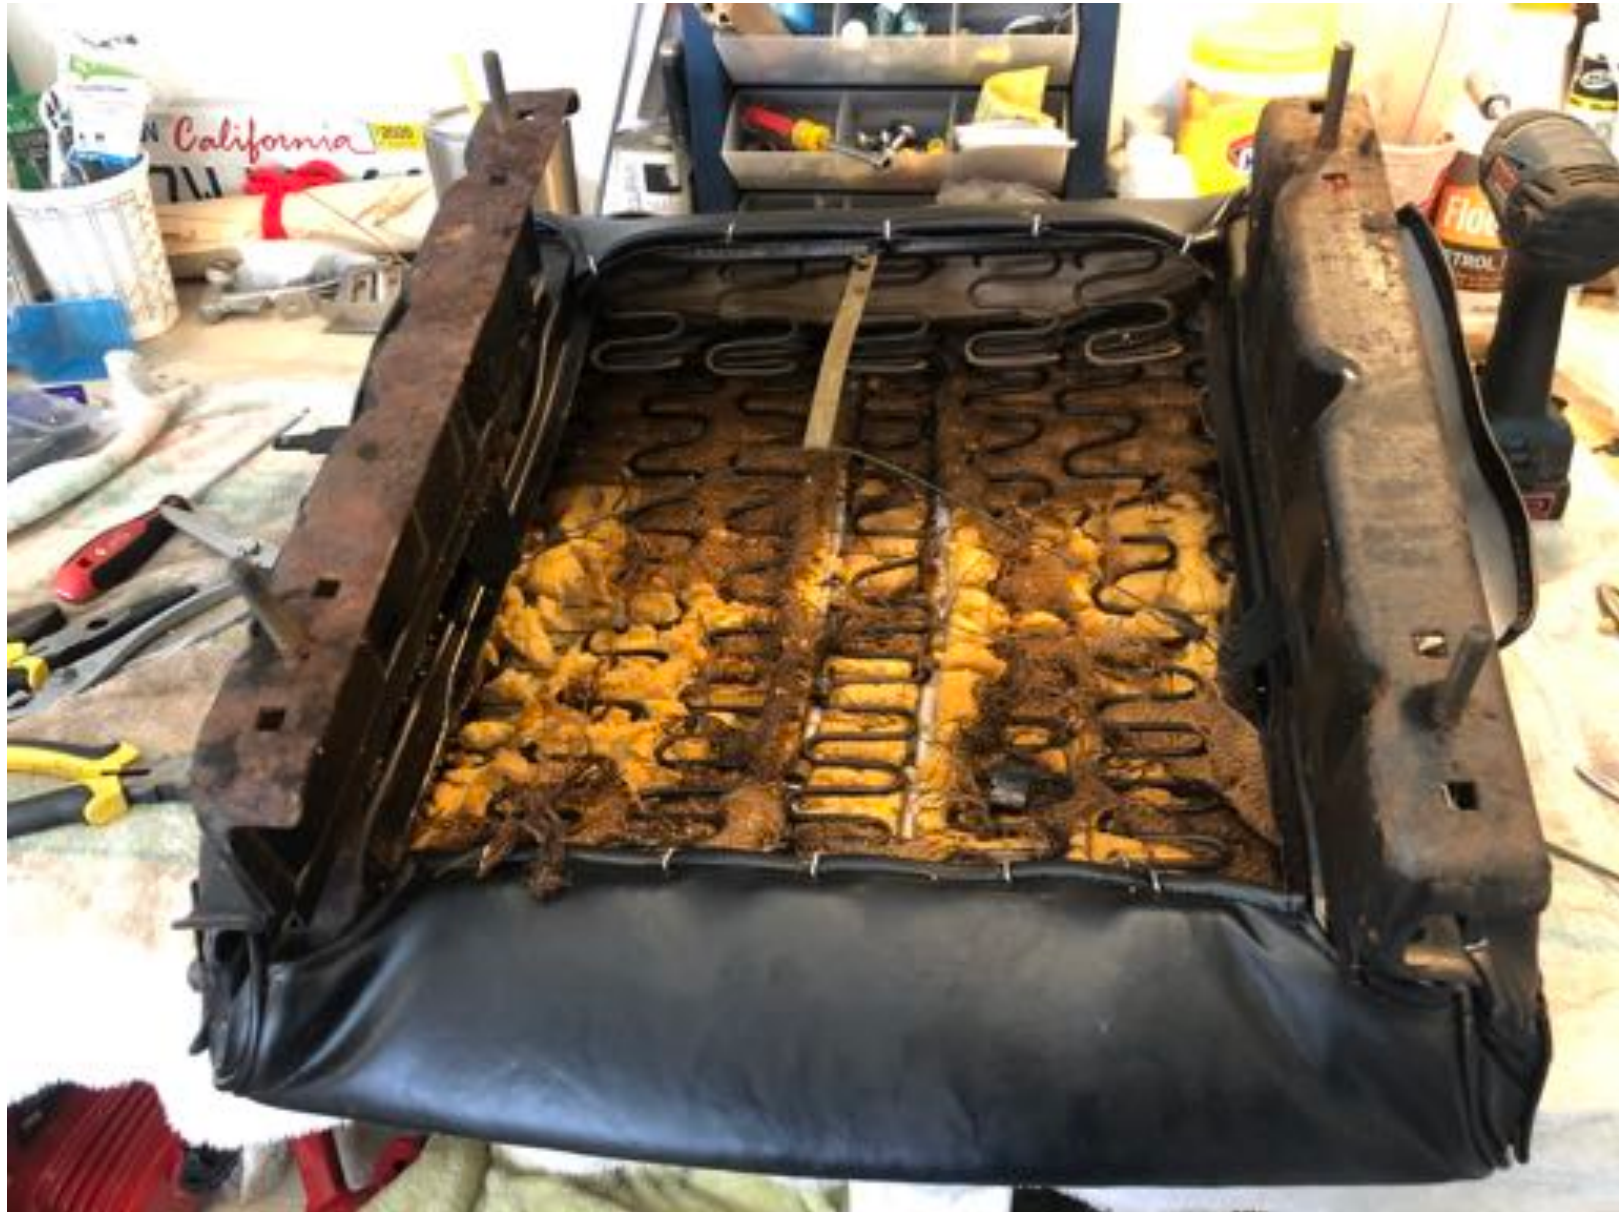
Underside of seat before disassembly, driver side was worse

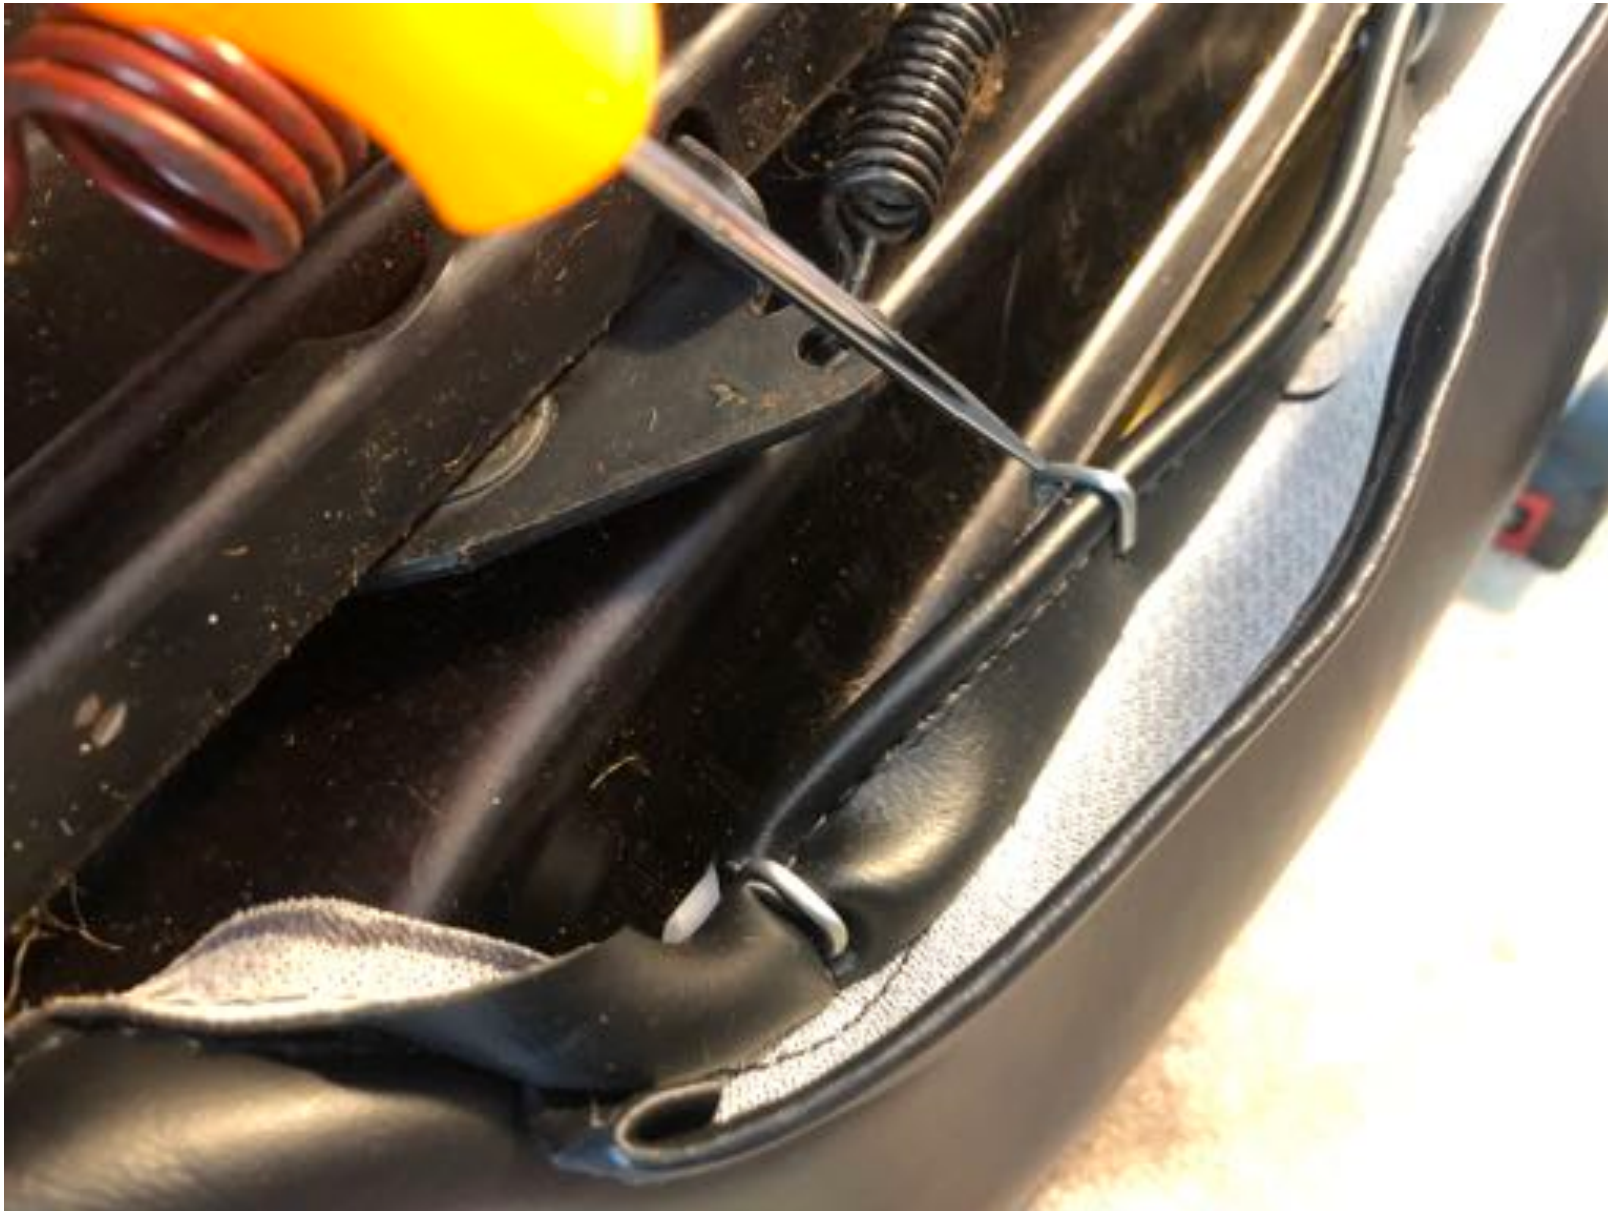
Existing seat cover is in great shape, remove all hog rings, maybe 18-20

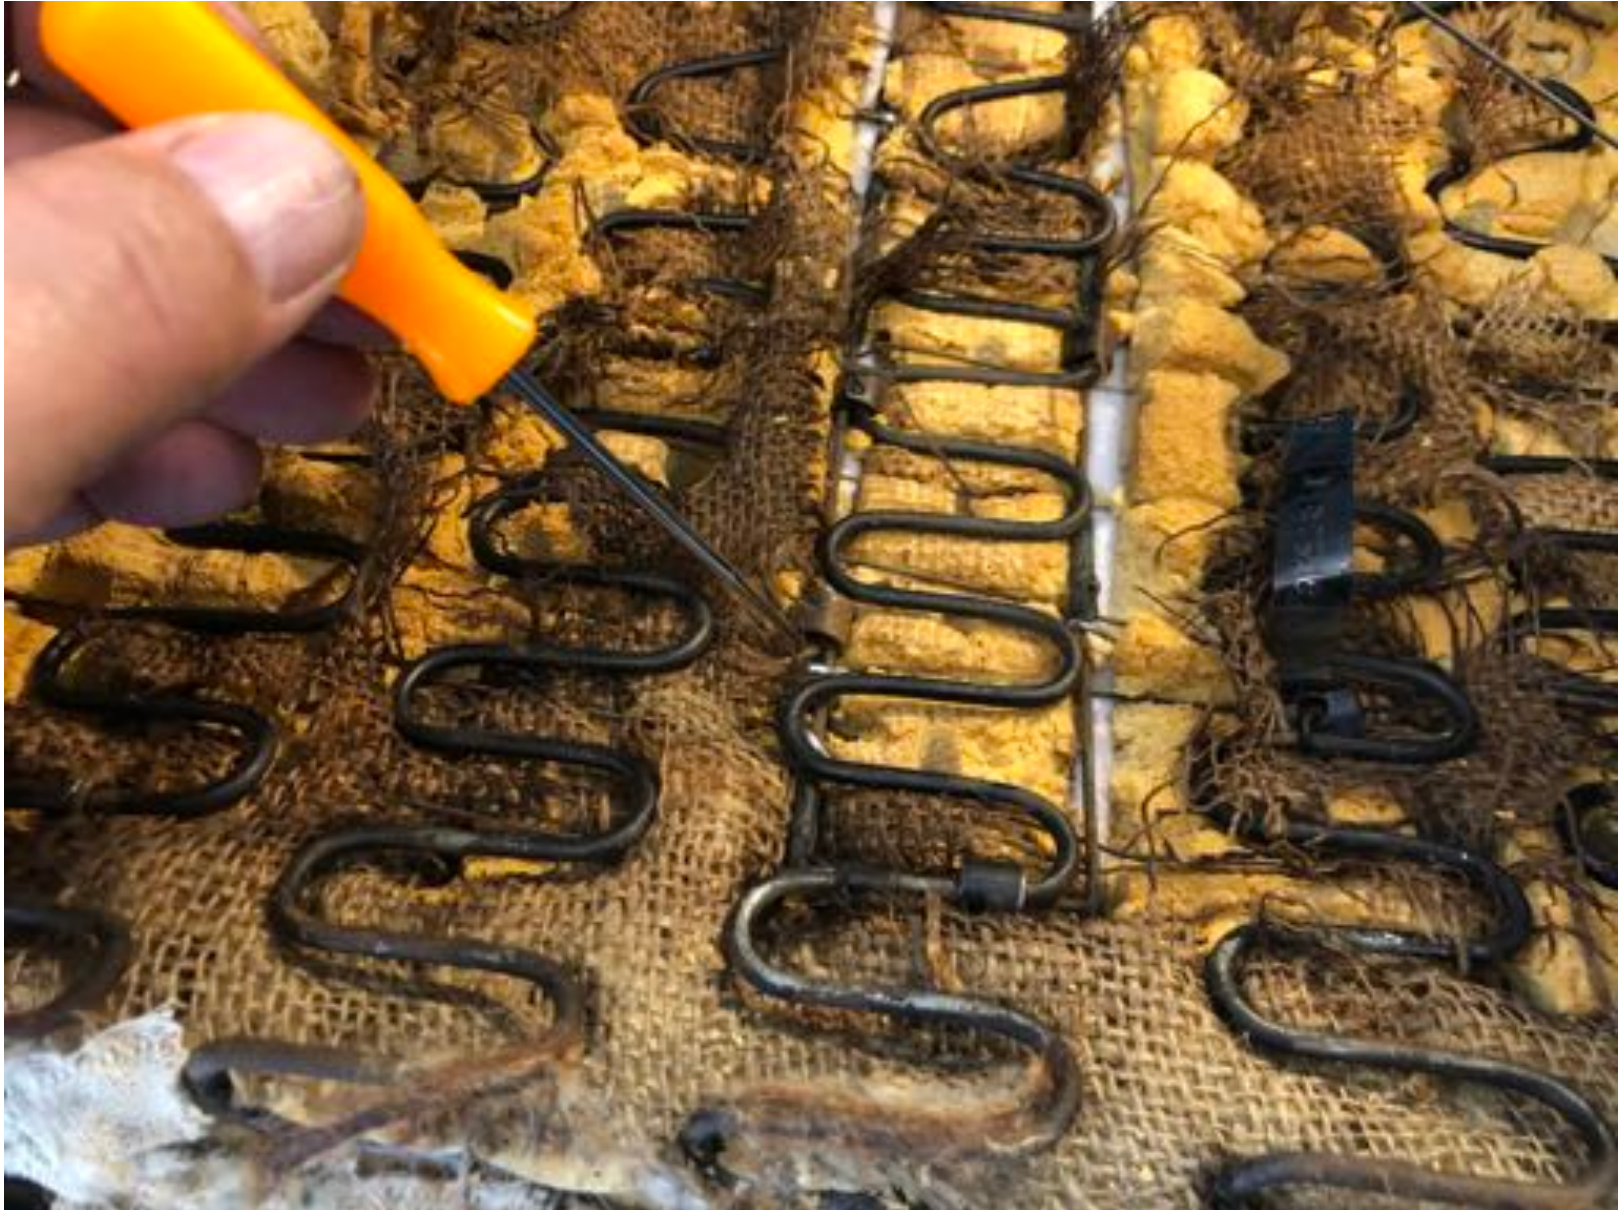
There were additional hog rings down the center, I did not reinstall these

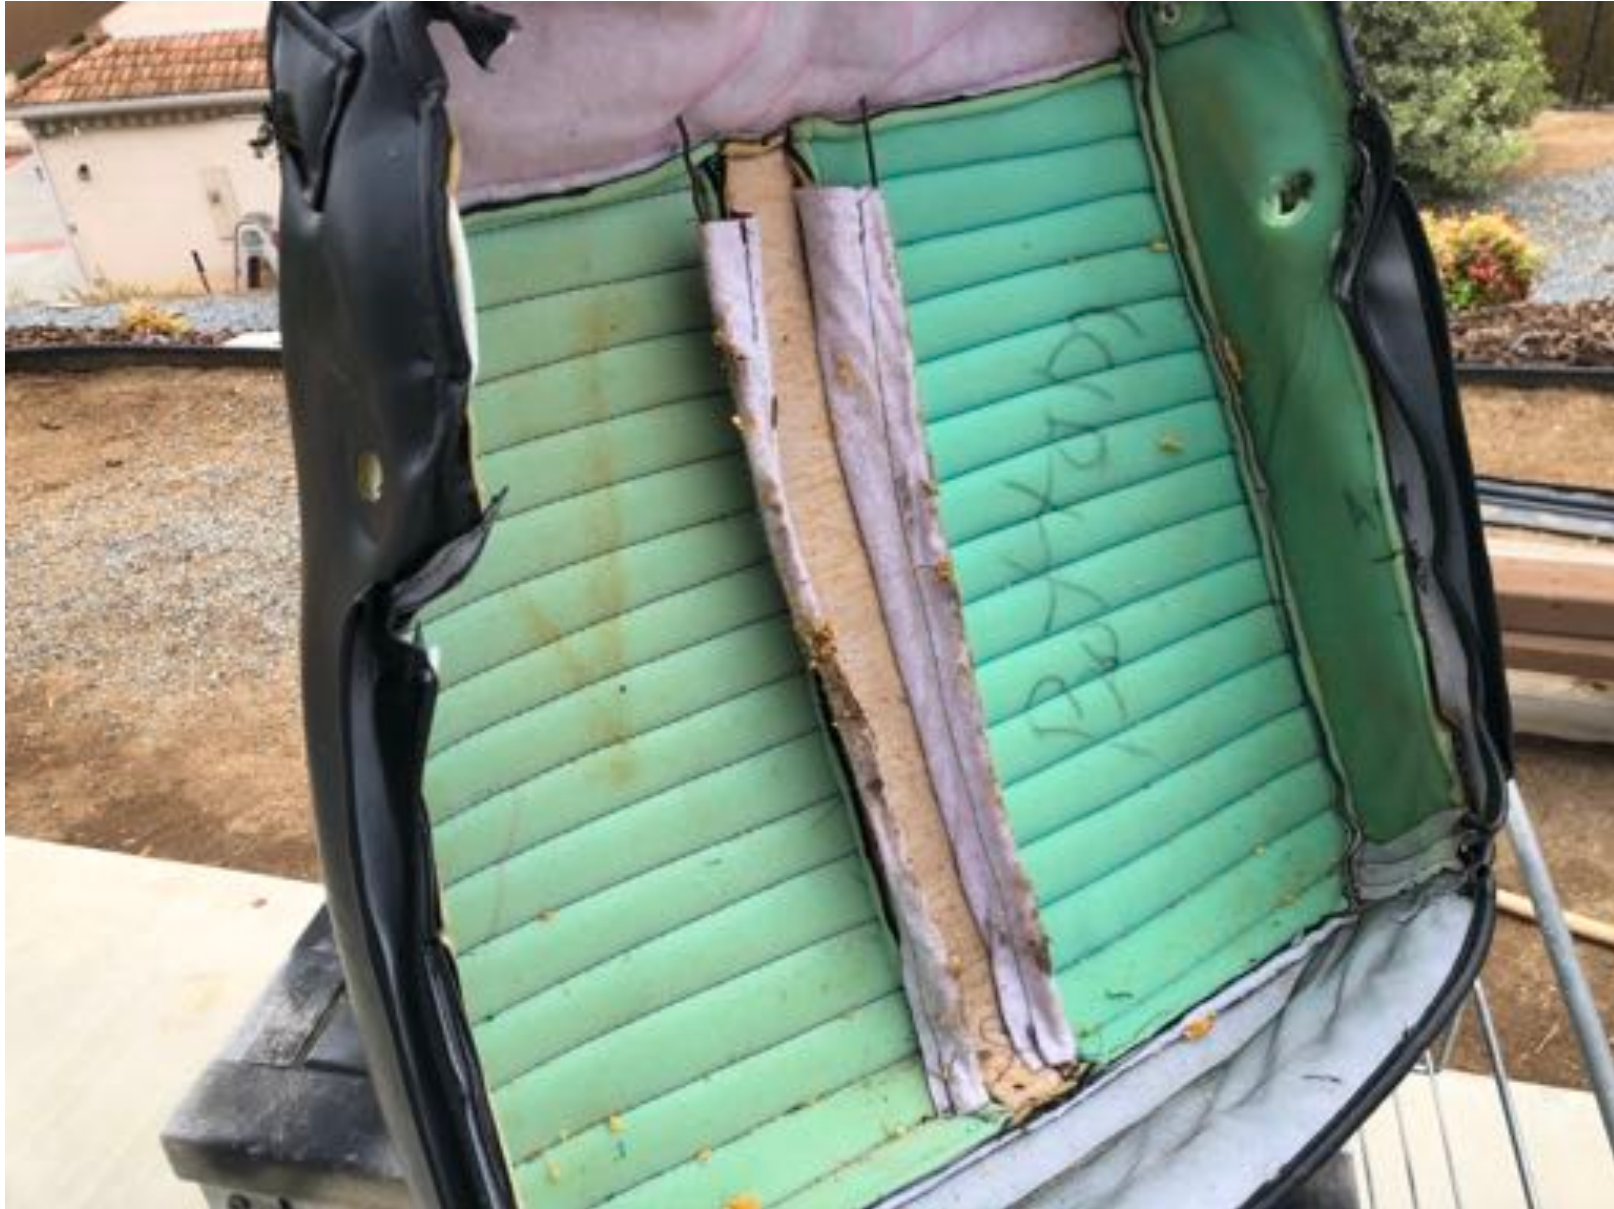
Removed seat cover. Notice the two panels, these fit into existing slots of old foam. I did not reinstall these, my foam didn't have the slots

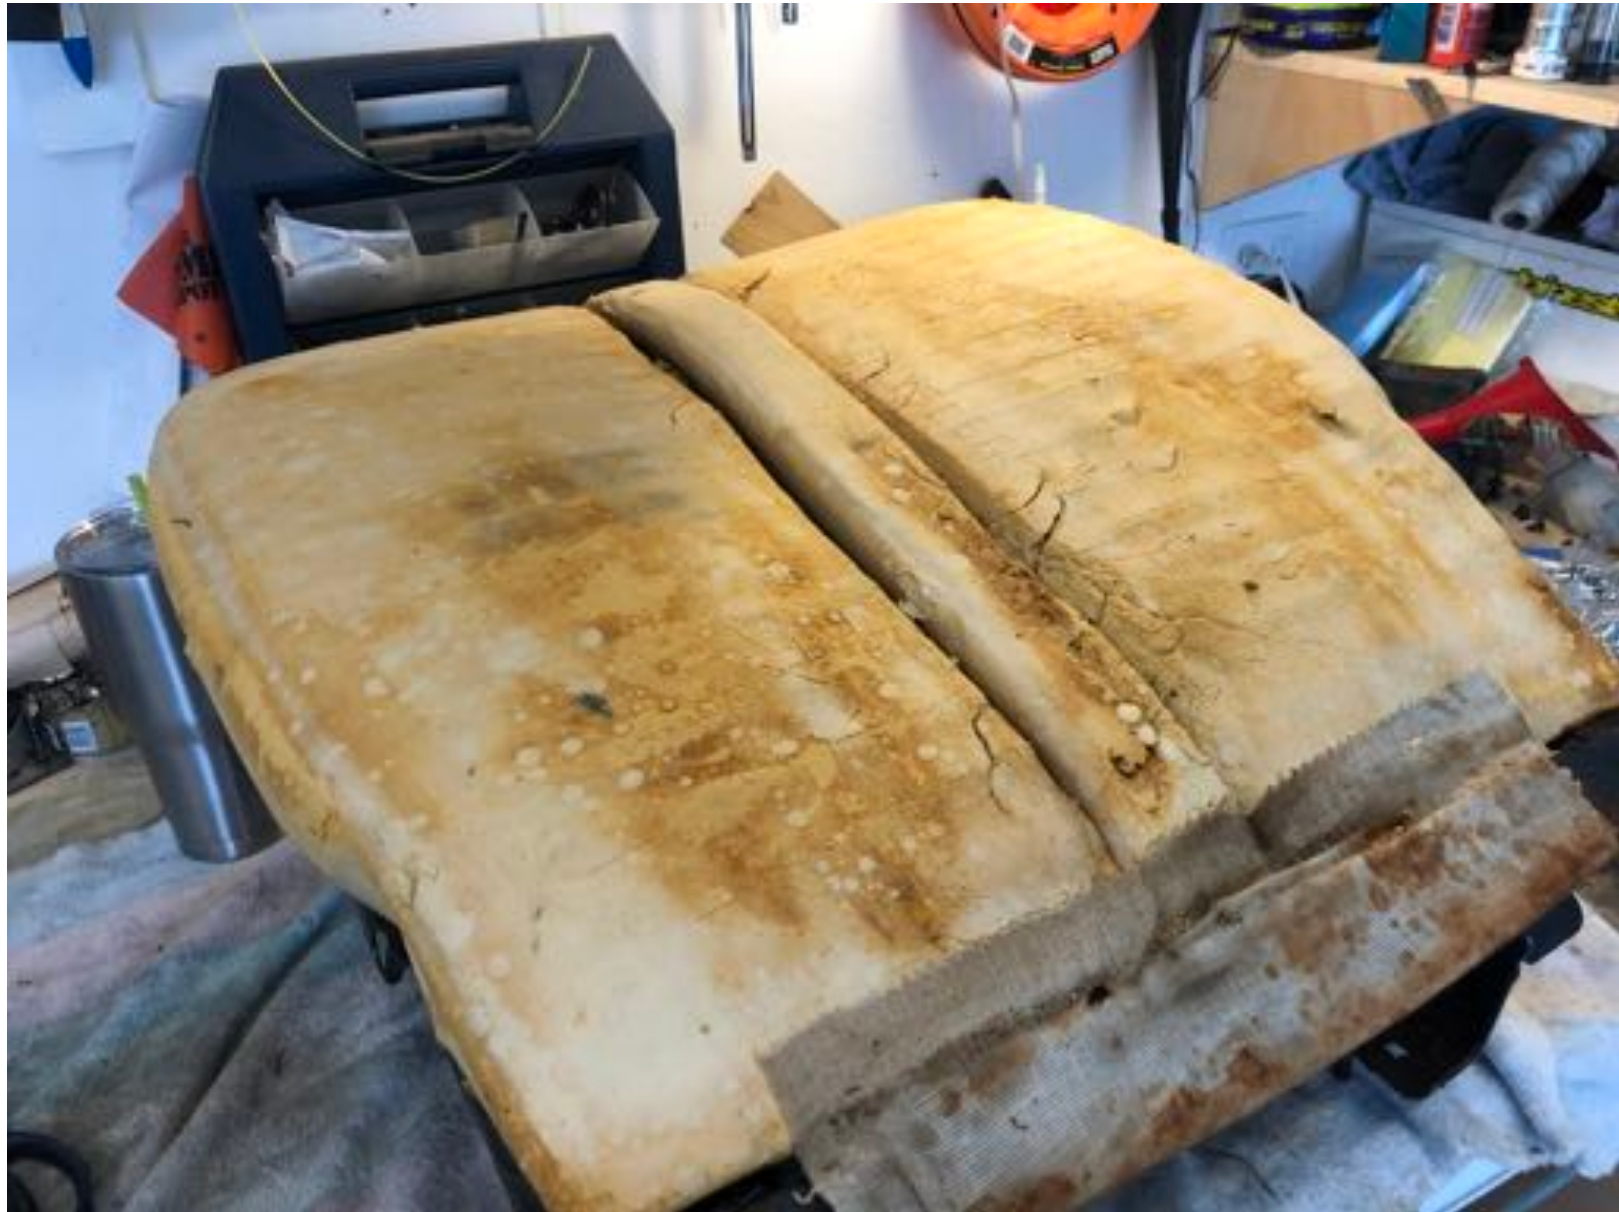
This the old foam, had the Chrysler part number stamped on the foam. Notice existing slots for the two panels to slide in. I did not reuse. I didn't feel comfortable cutting slots

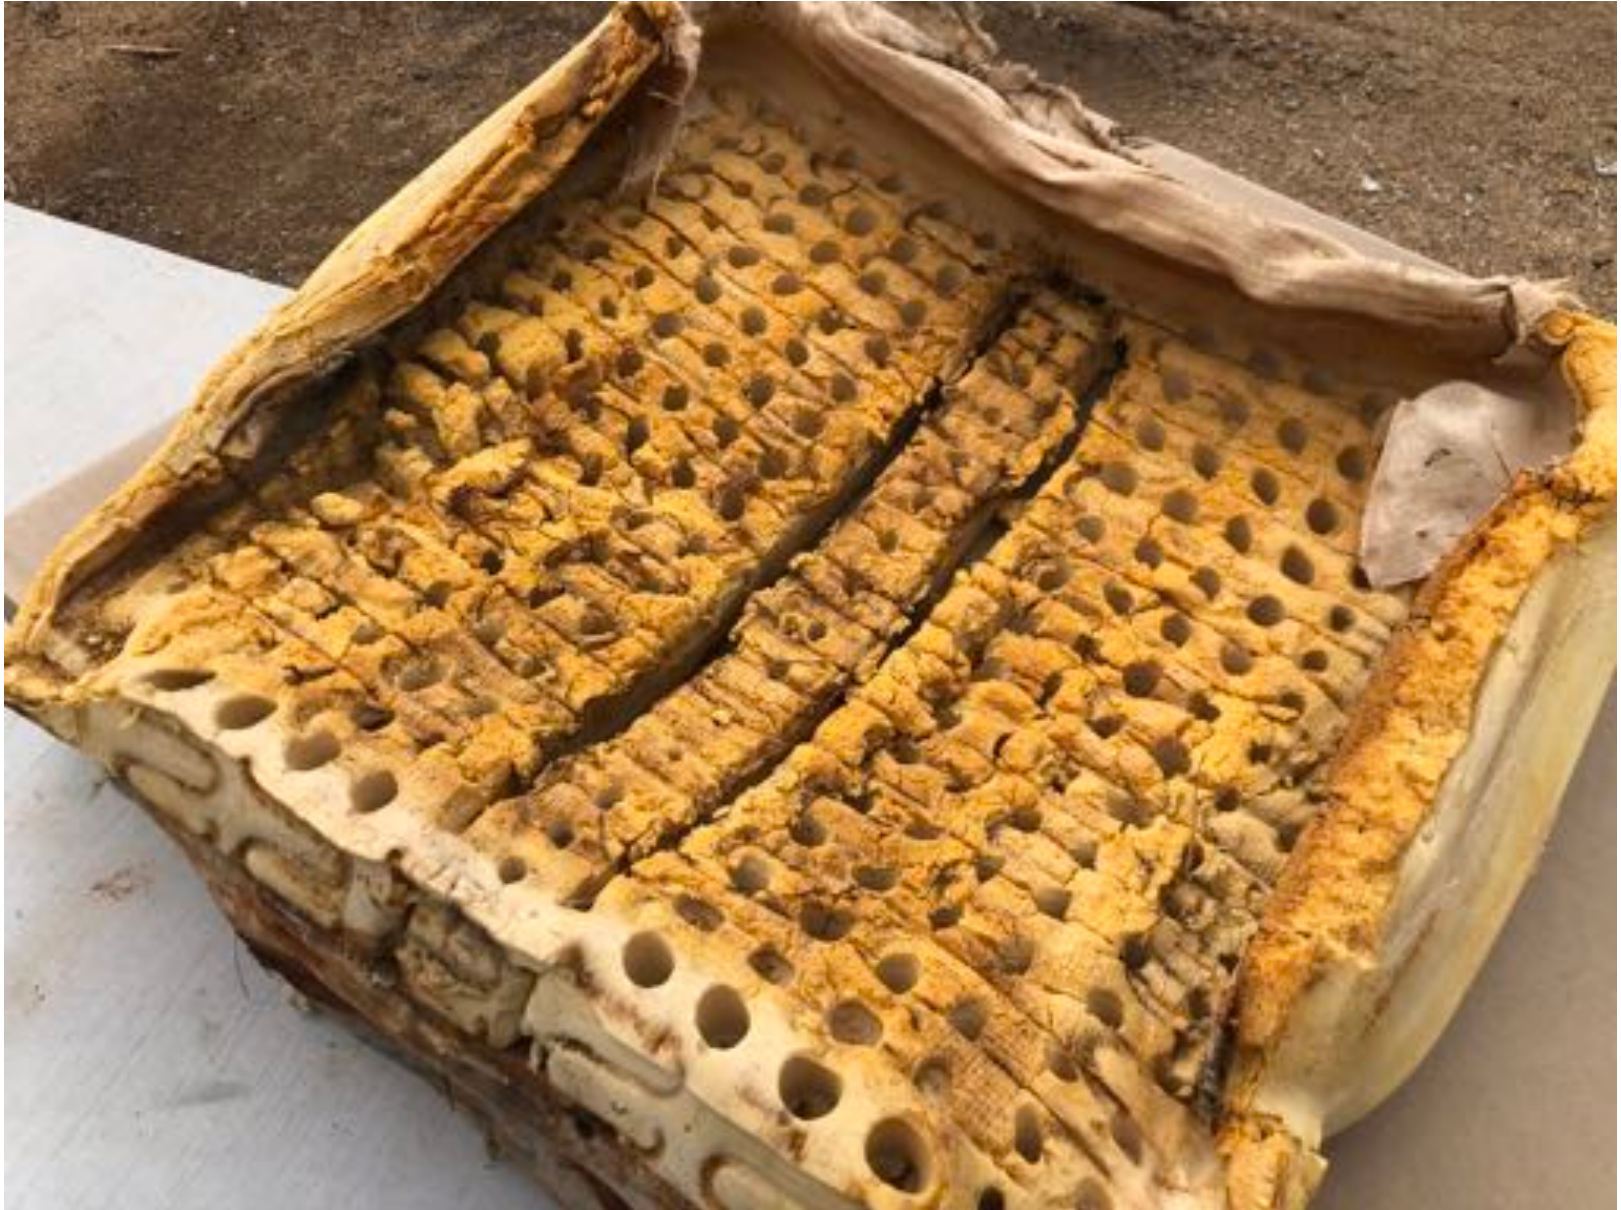
Underside of old foam, you can still see the slots. Really deteriorated badly, drivers side was way worse.

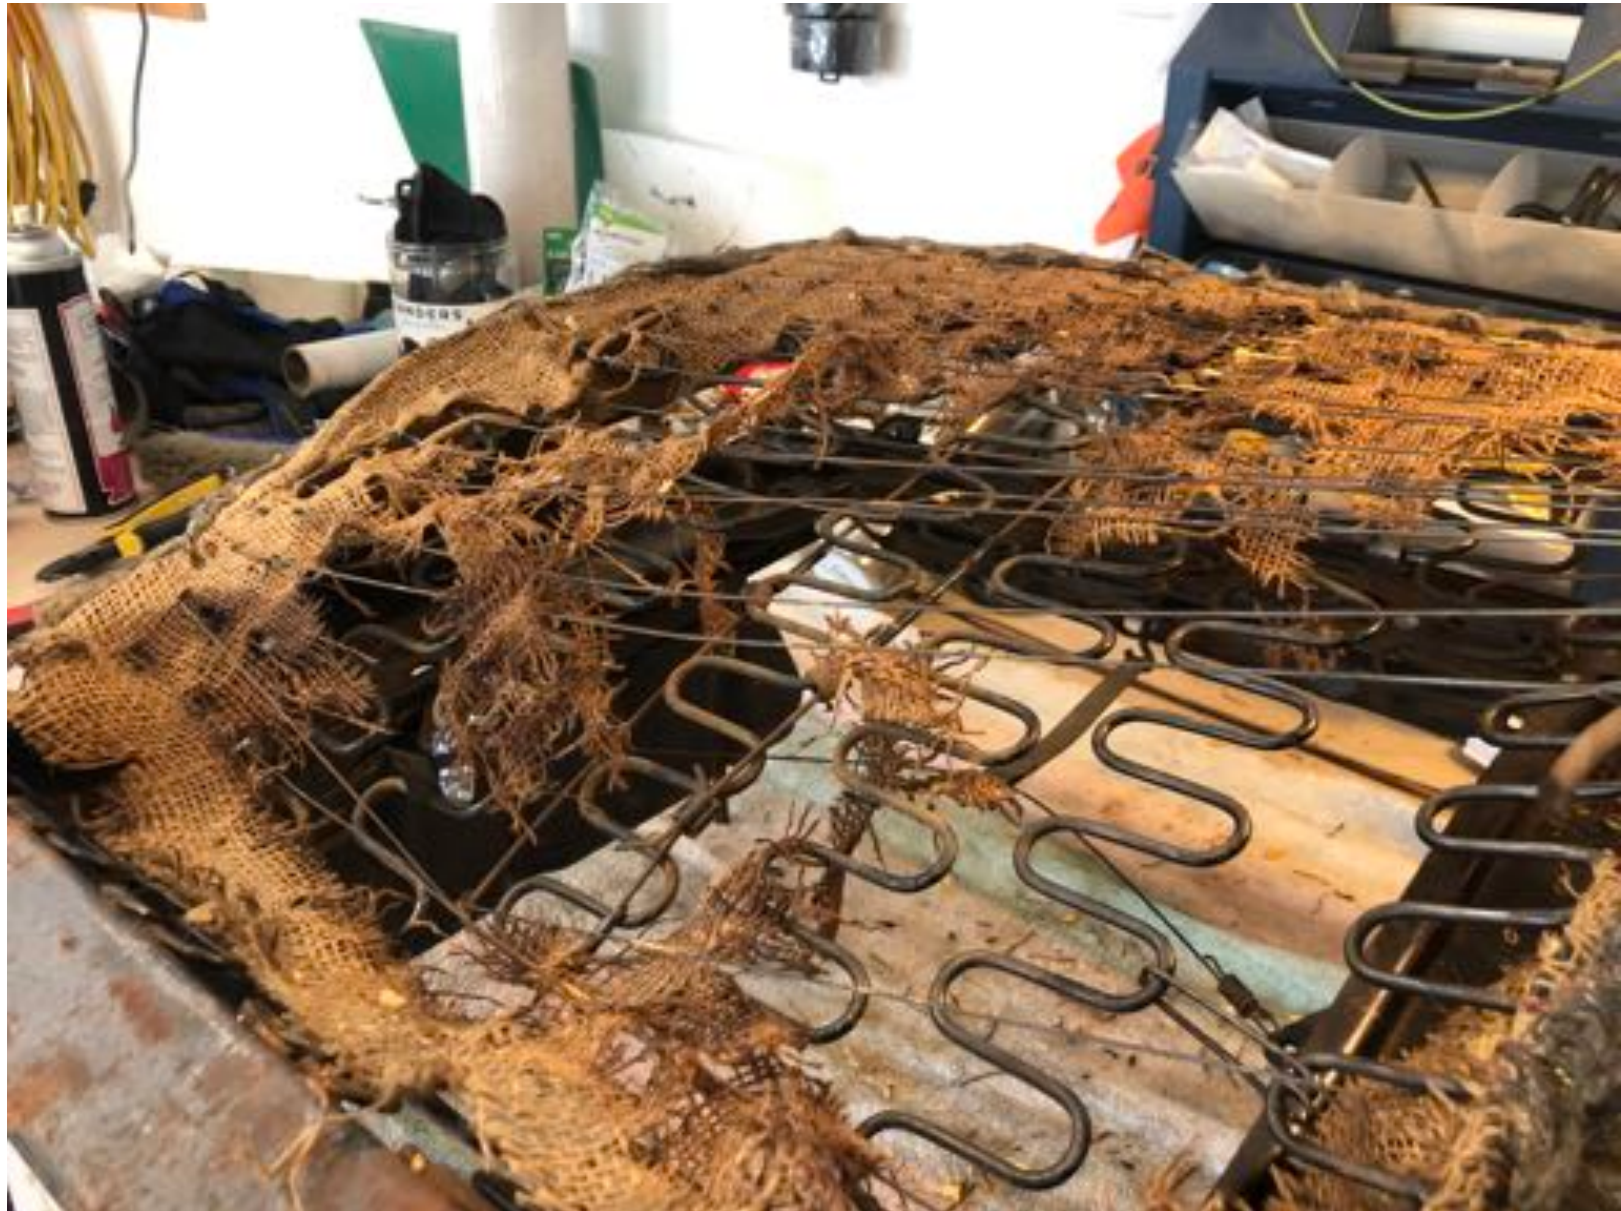
Seat frame is starting to be visible, notice another wire mesh with burlap, I remove this.

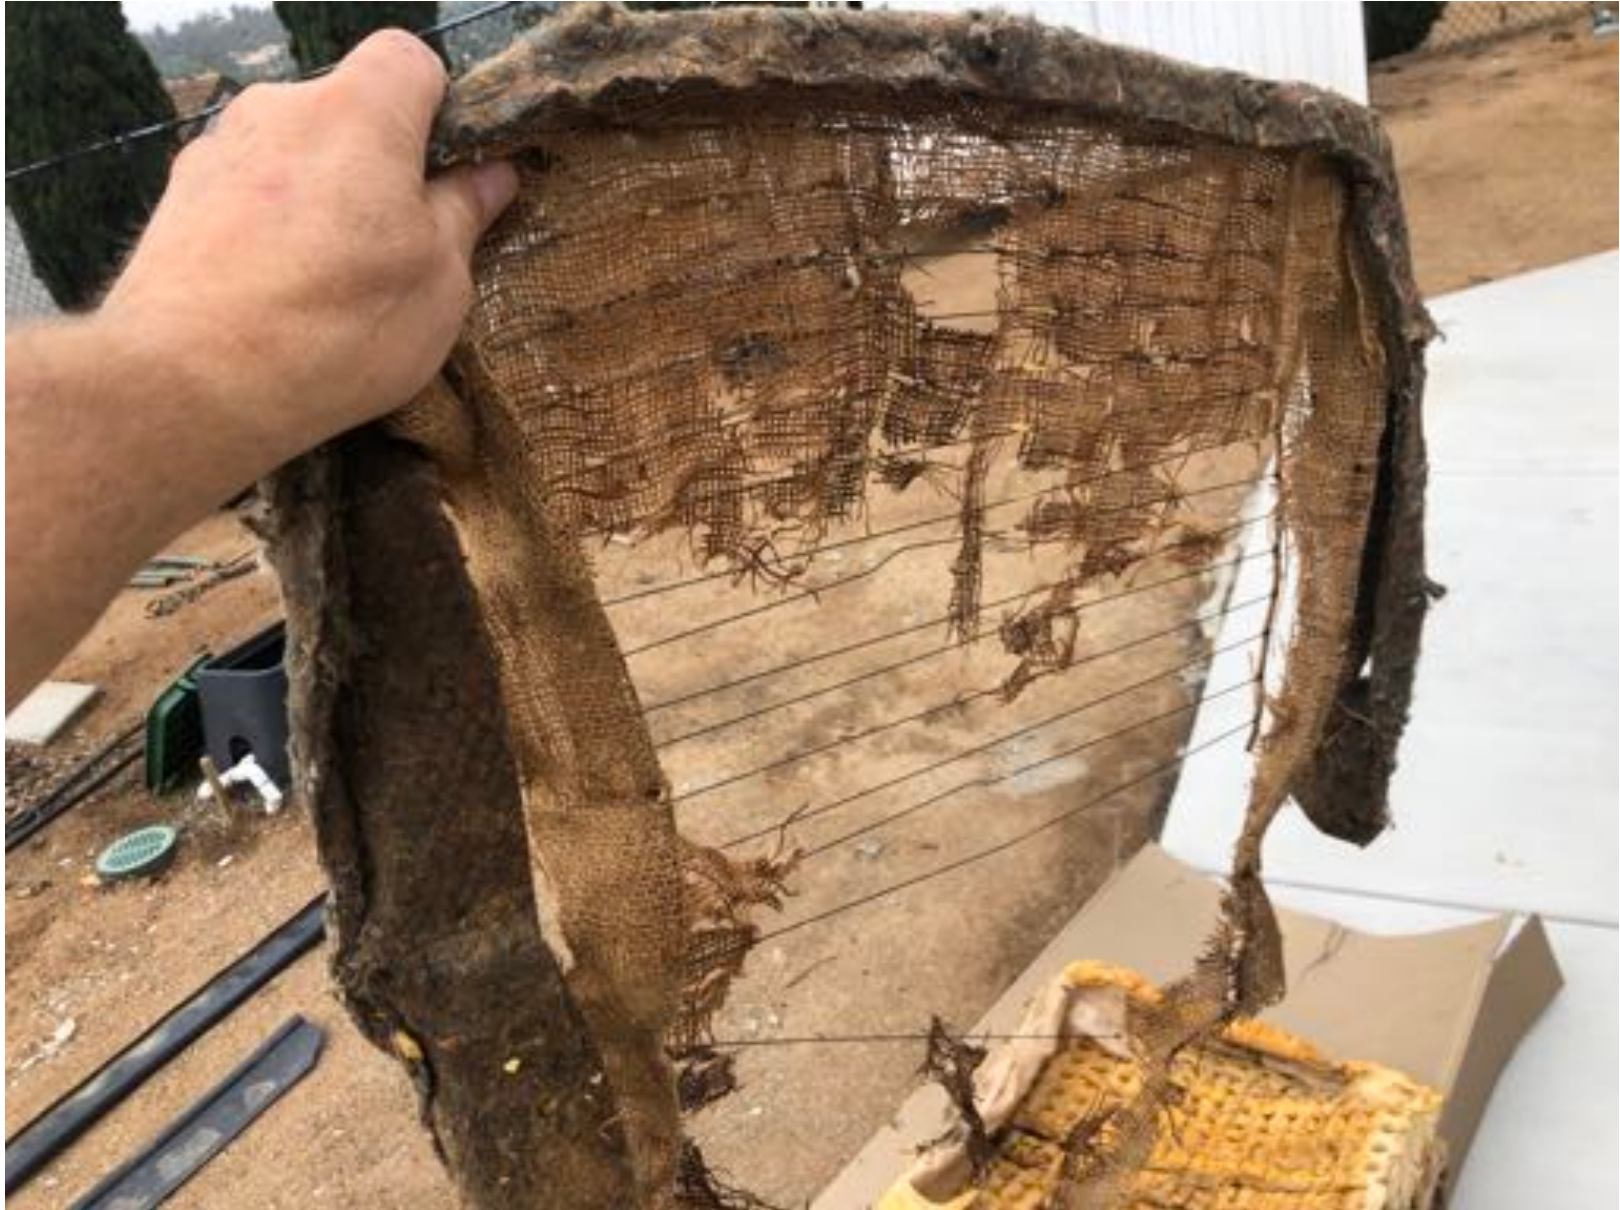
Wire mesh with burlap, removed

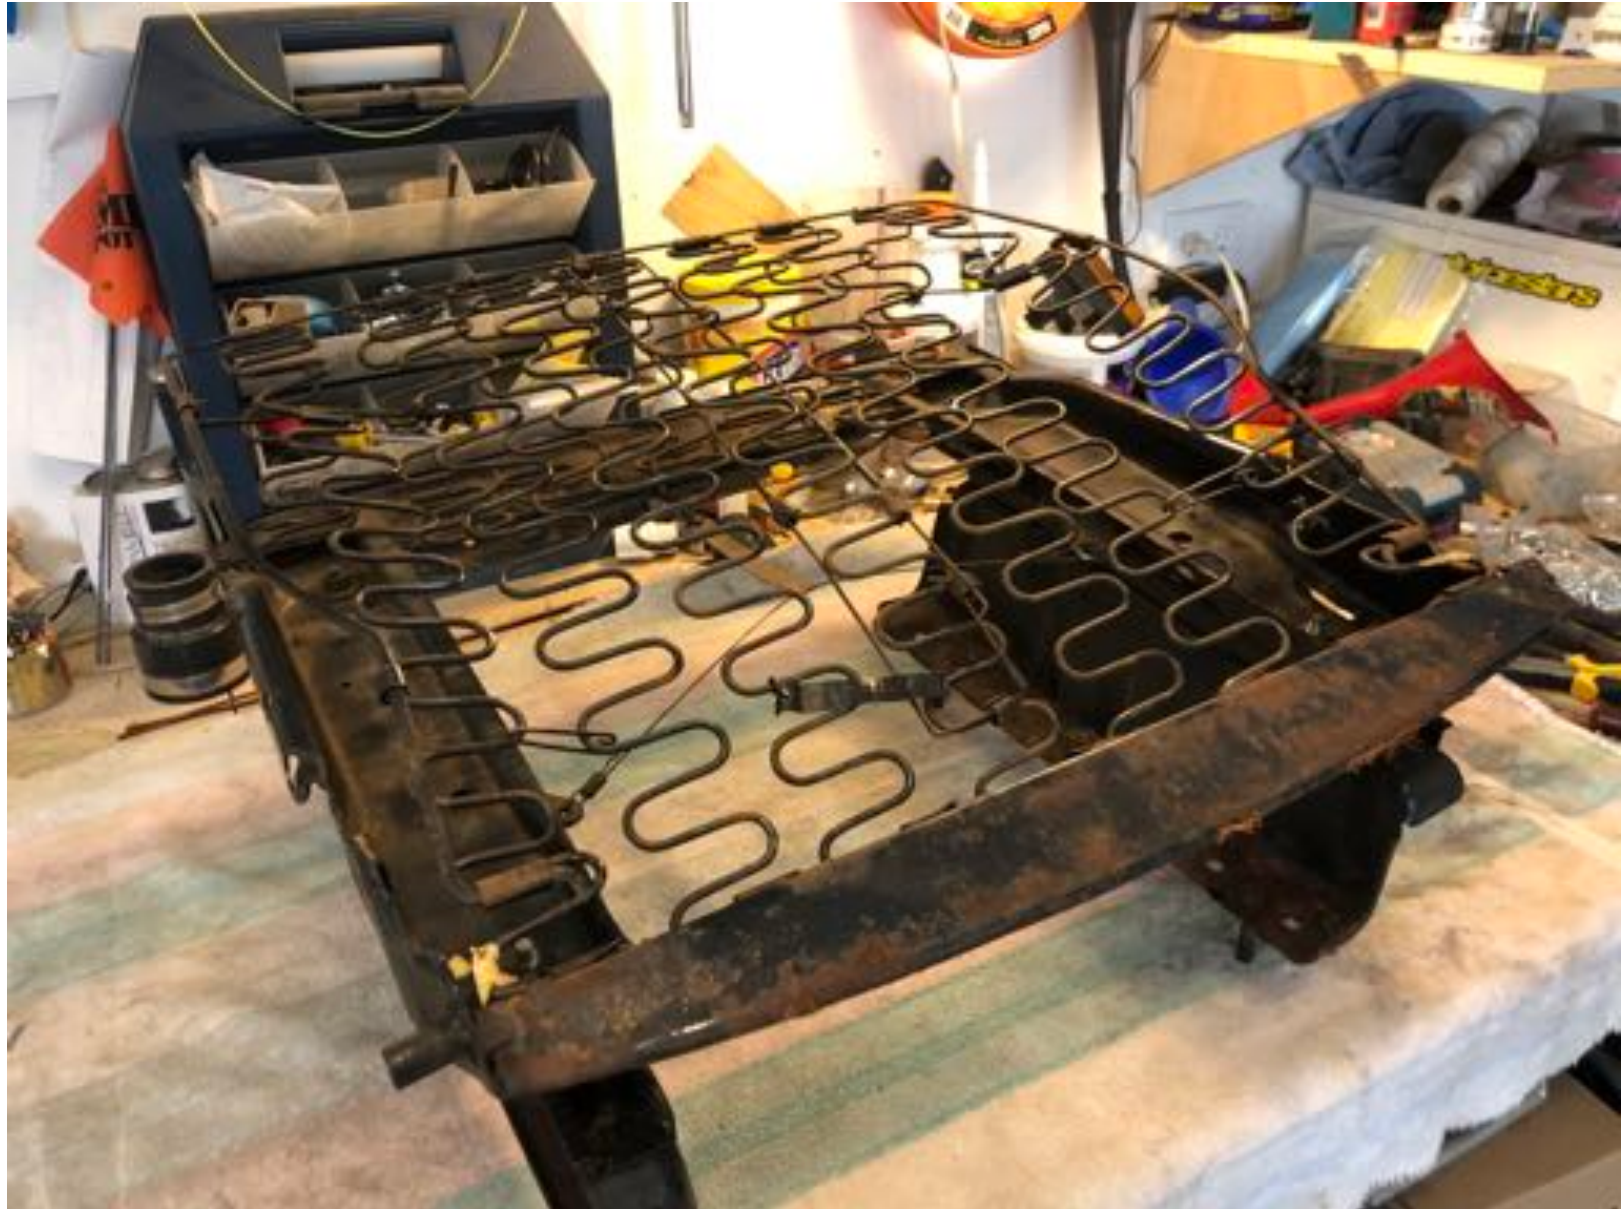
Frame & springs with all burlap and foam removed. Cleaned and vacuumed
