67 Satellite passenger seat  
rebuild

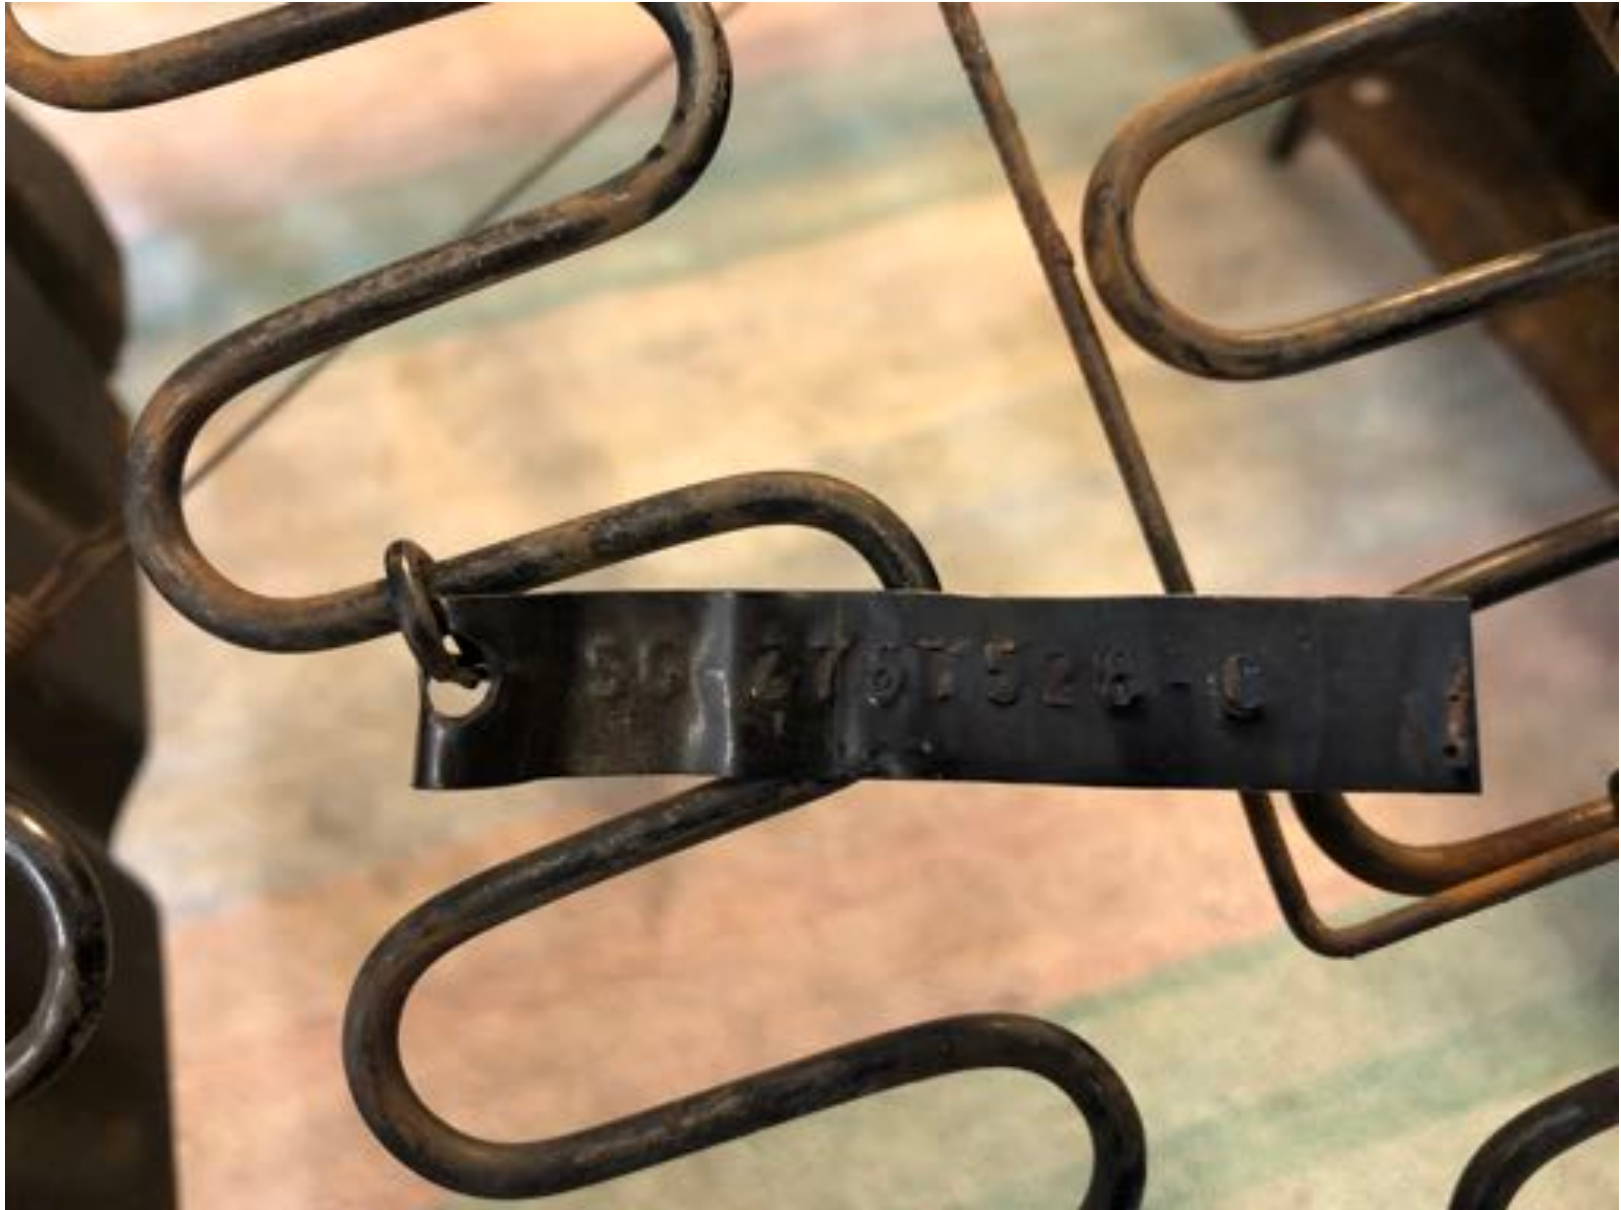
Found this small tag attached to the spring, I left it

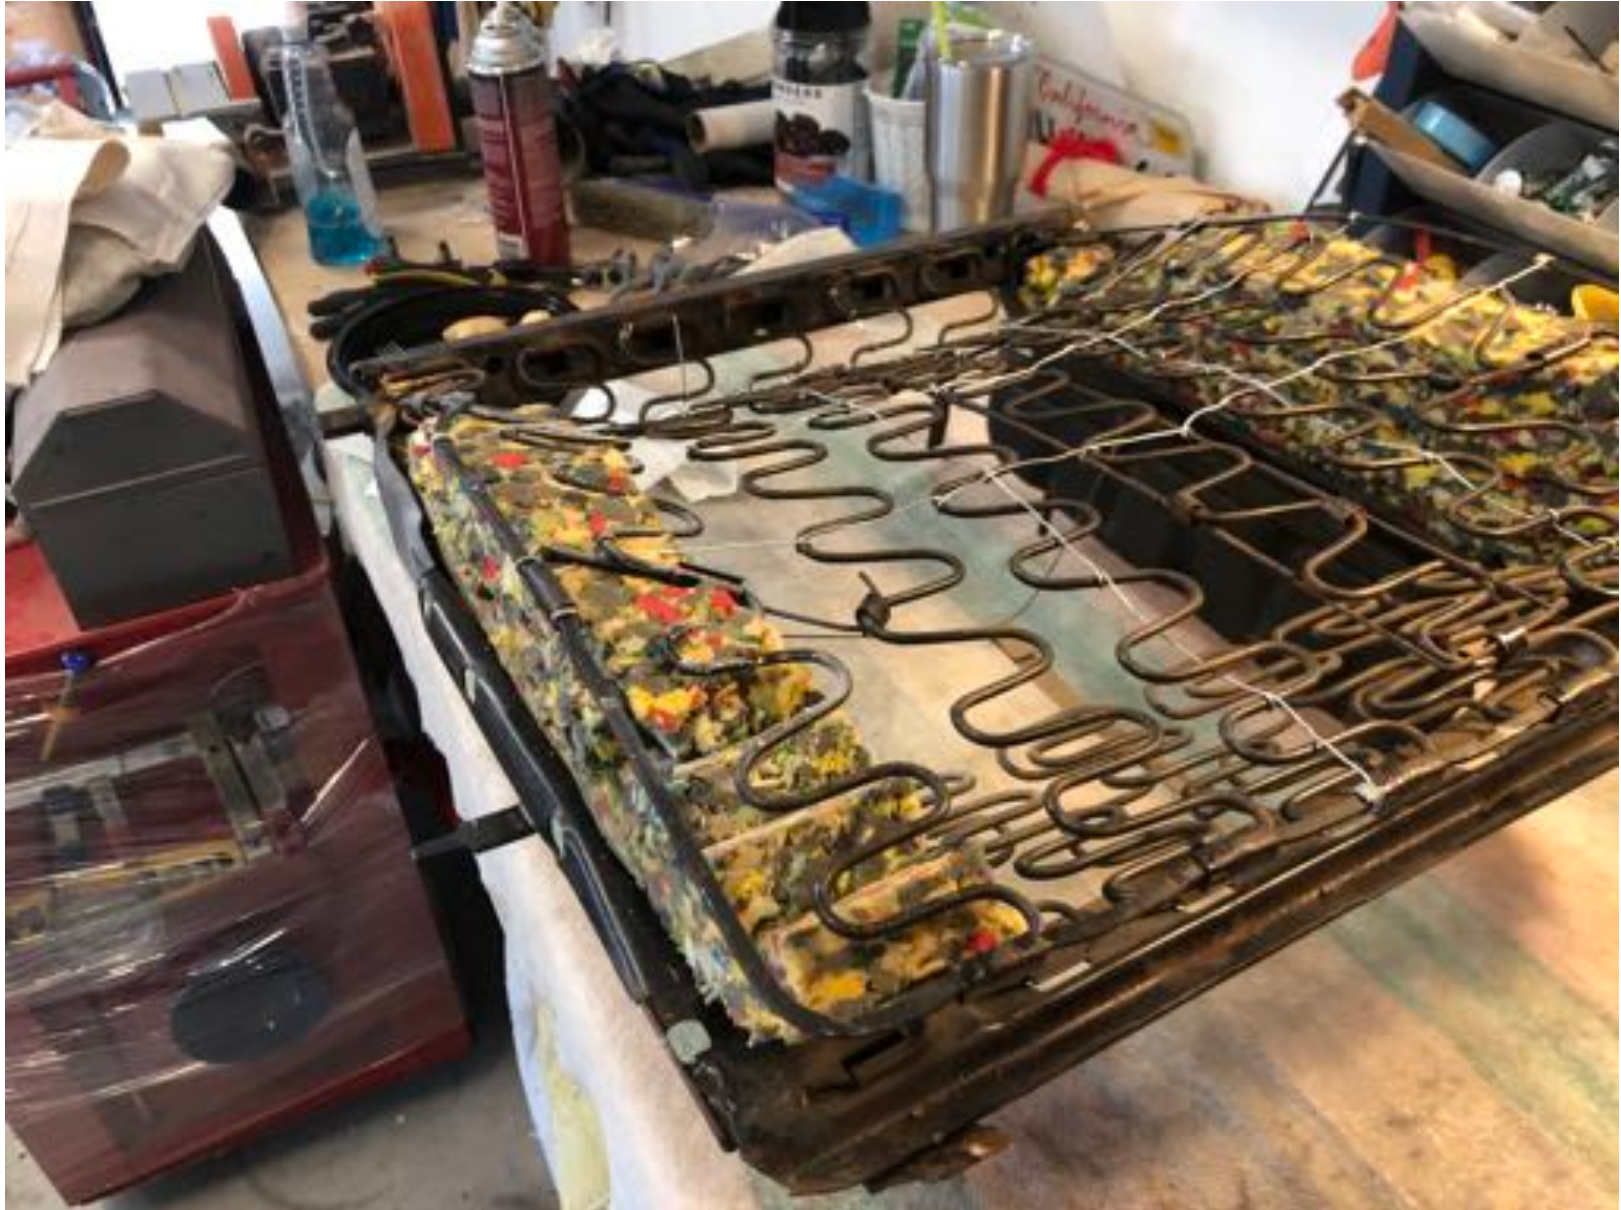
Another angle showing added high density foam

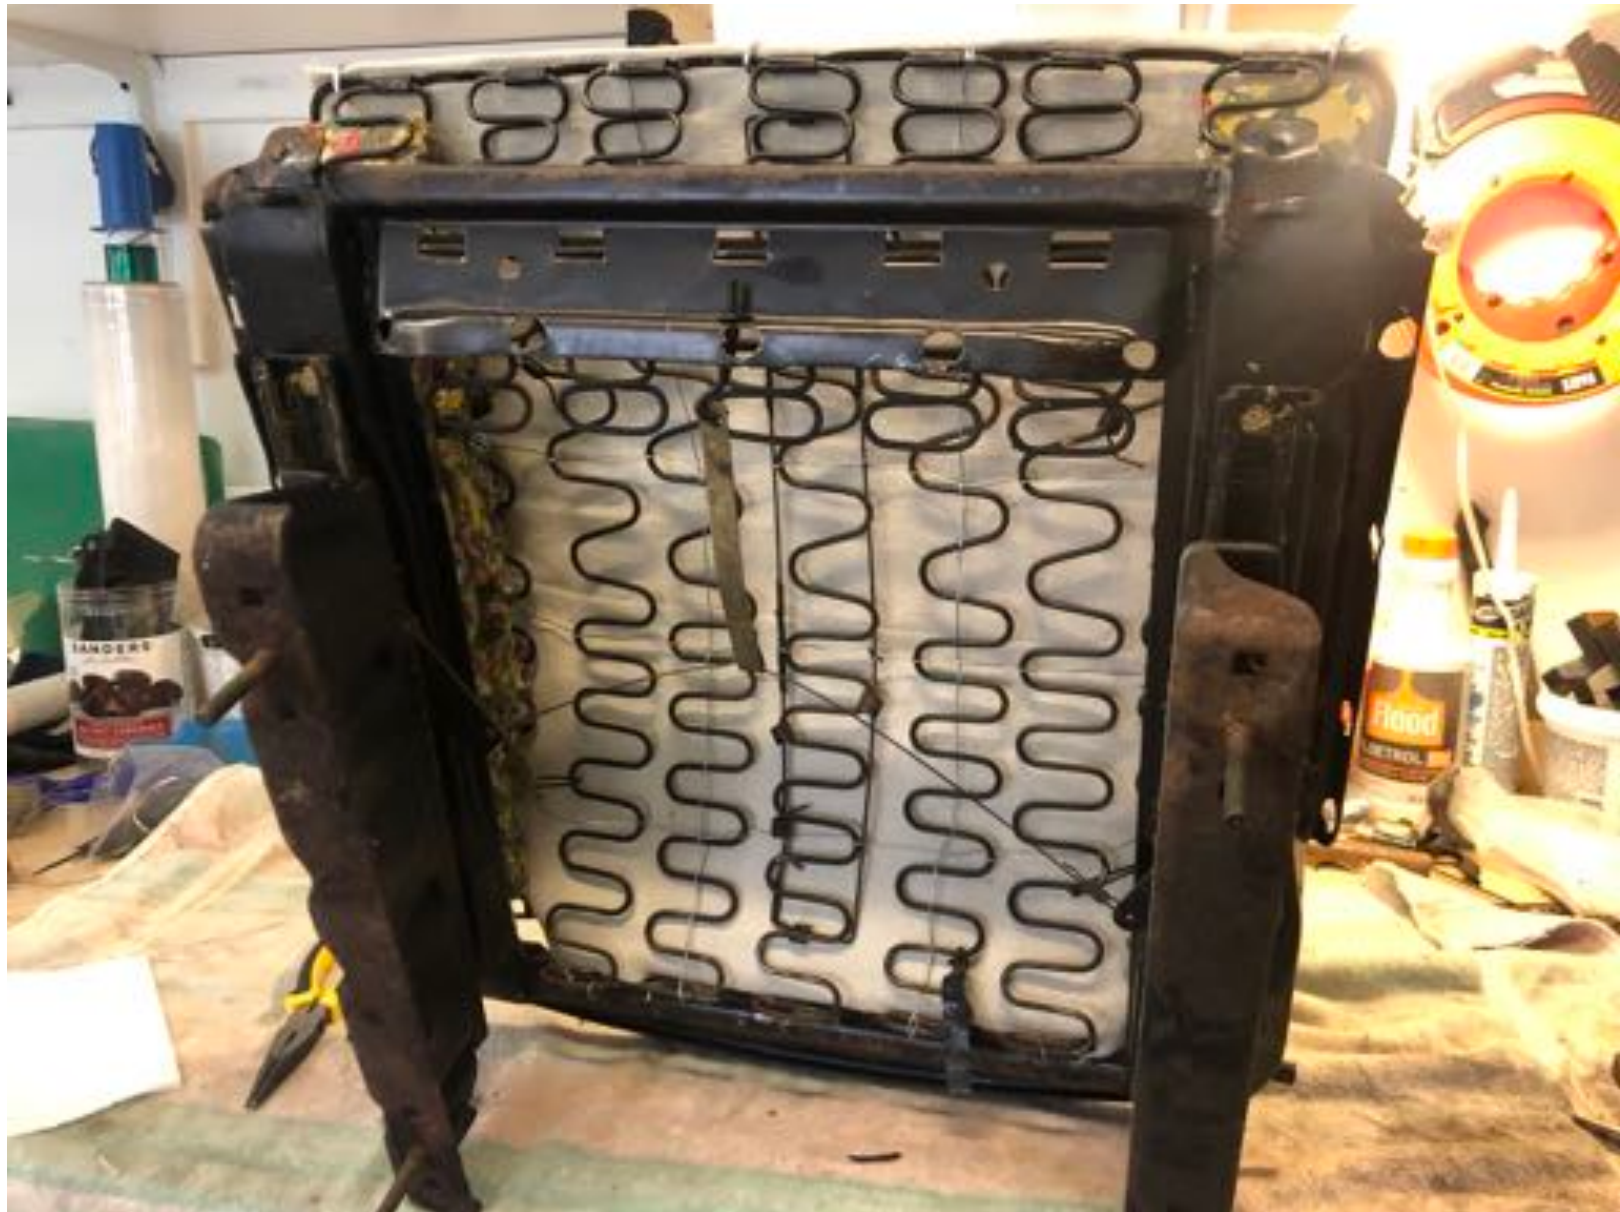
View from the underside

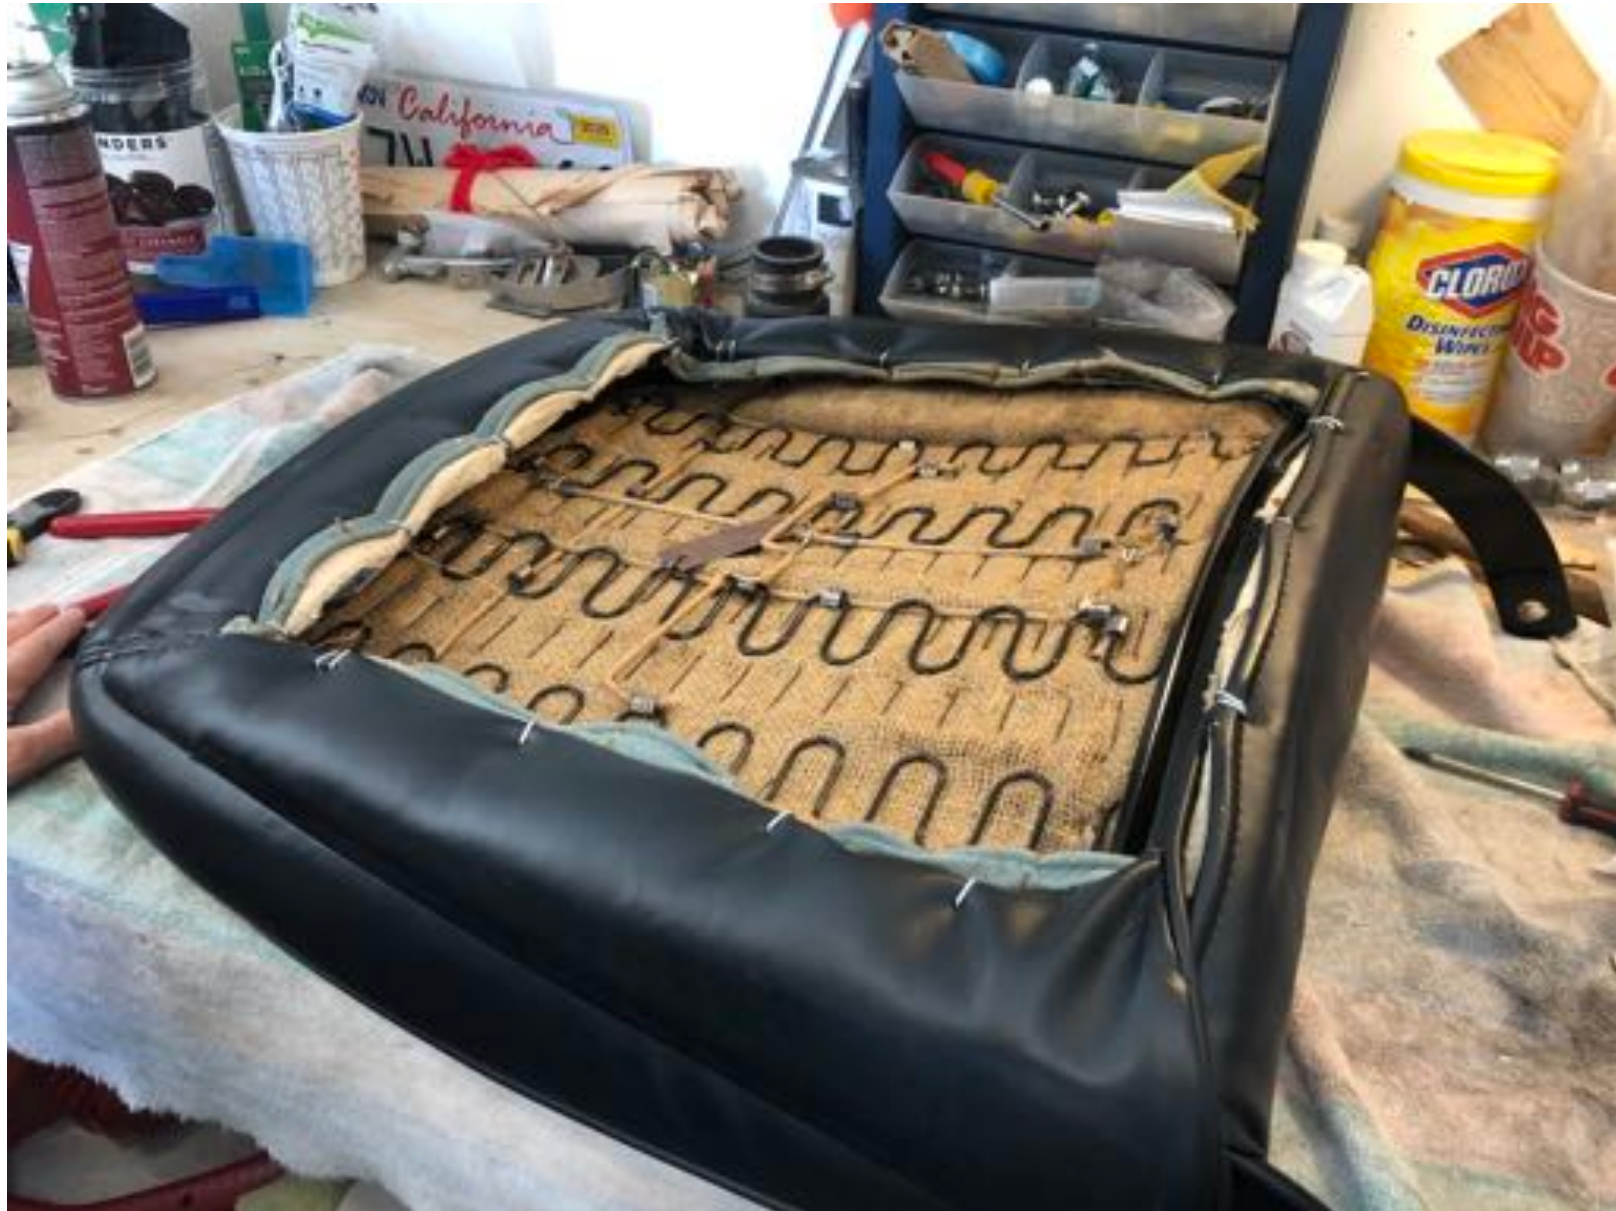
This is the original seat back. It was in such good shape I left it.
